FilaOut: VSI performance improvement and board checkout

M. Wunderlich 21Oct2012-11-21 mwunderlich@mpifr-bonn.mpg.de

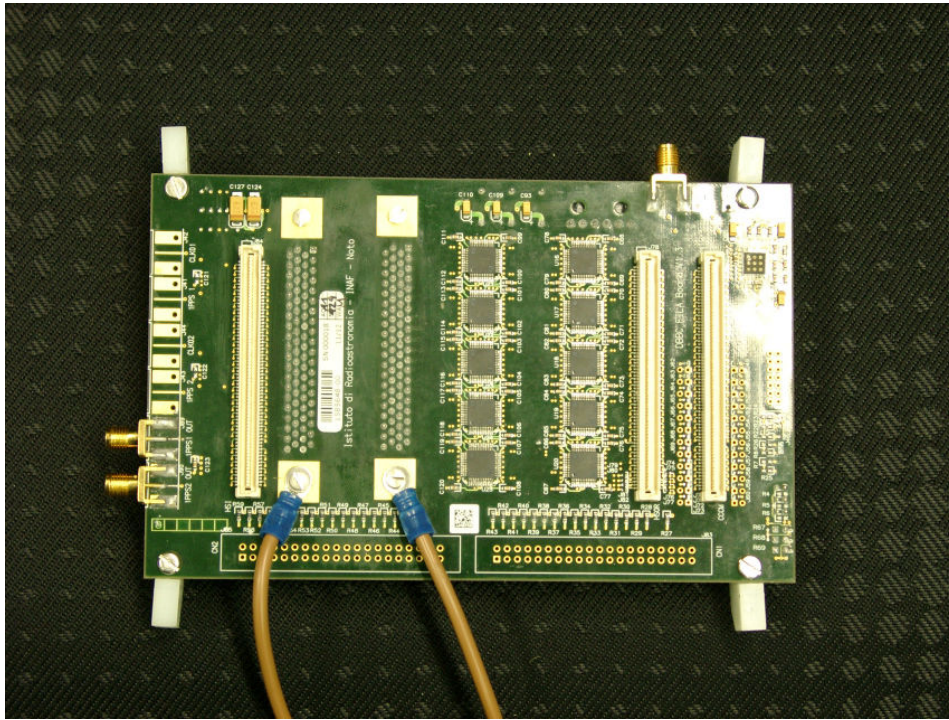
For some reasons the shielding of a VSI cable was not connected to the DBBC ground in earlier systems. This could produce common mode biases in the drivers and thus a strange behaviour of the VSI in some cases.

It is quite easy to correct this. Use 4 flathead screws M2.5 to fasten the VSI connectors to FilaOut board properly. Use two of these screws to connect ground straps to the rectangular copper area which is floating in respect to the system ground.

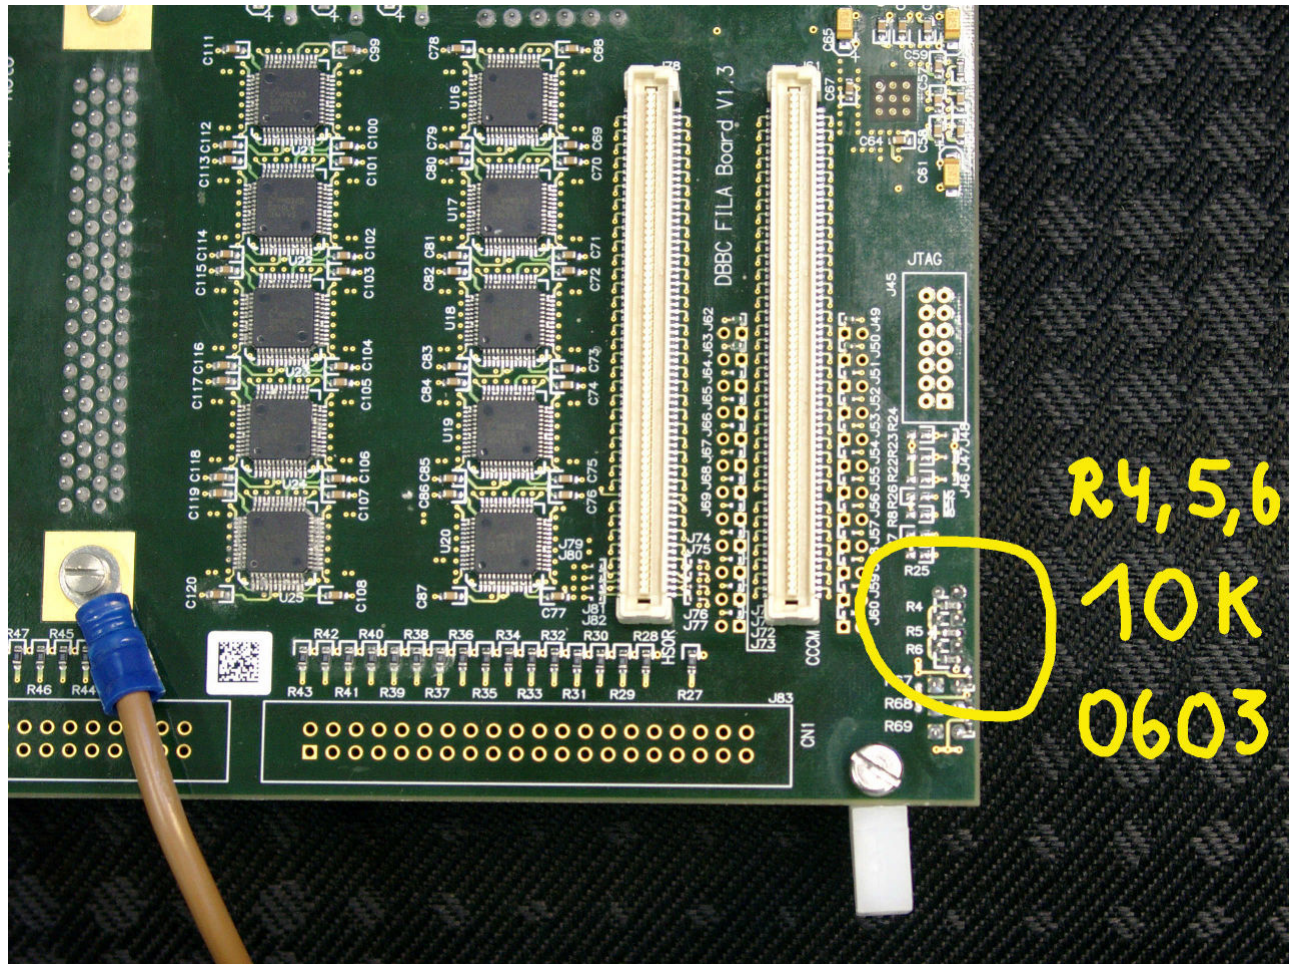
R6 problem:

There have been a couple of problems due to a manufacturing error. On some of the boards the resistors shown below had not been populated. In some cases this prevents the VSI output from working properly (intermittant signals and that sort of things). Make sure that these resistors have been placed, the most crucial one is R6. All three of them are standard SMD components size 0603. The nominal value is 10KOhm, but if these are not available at your site, any value between 1K and 10K will do.
