PCI-7200 (no-write) problem

M. Wunderlich 21Oct2012-11-21 mwunderlich@mpifr-bonn.mpg.de

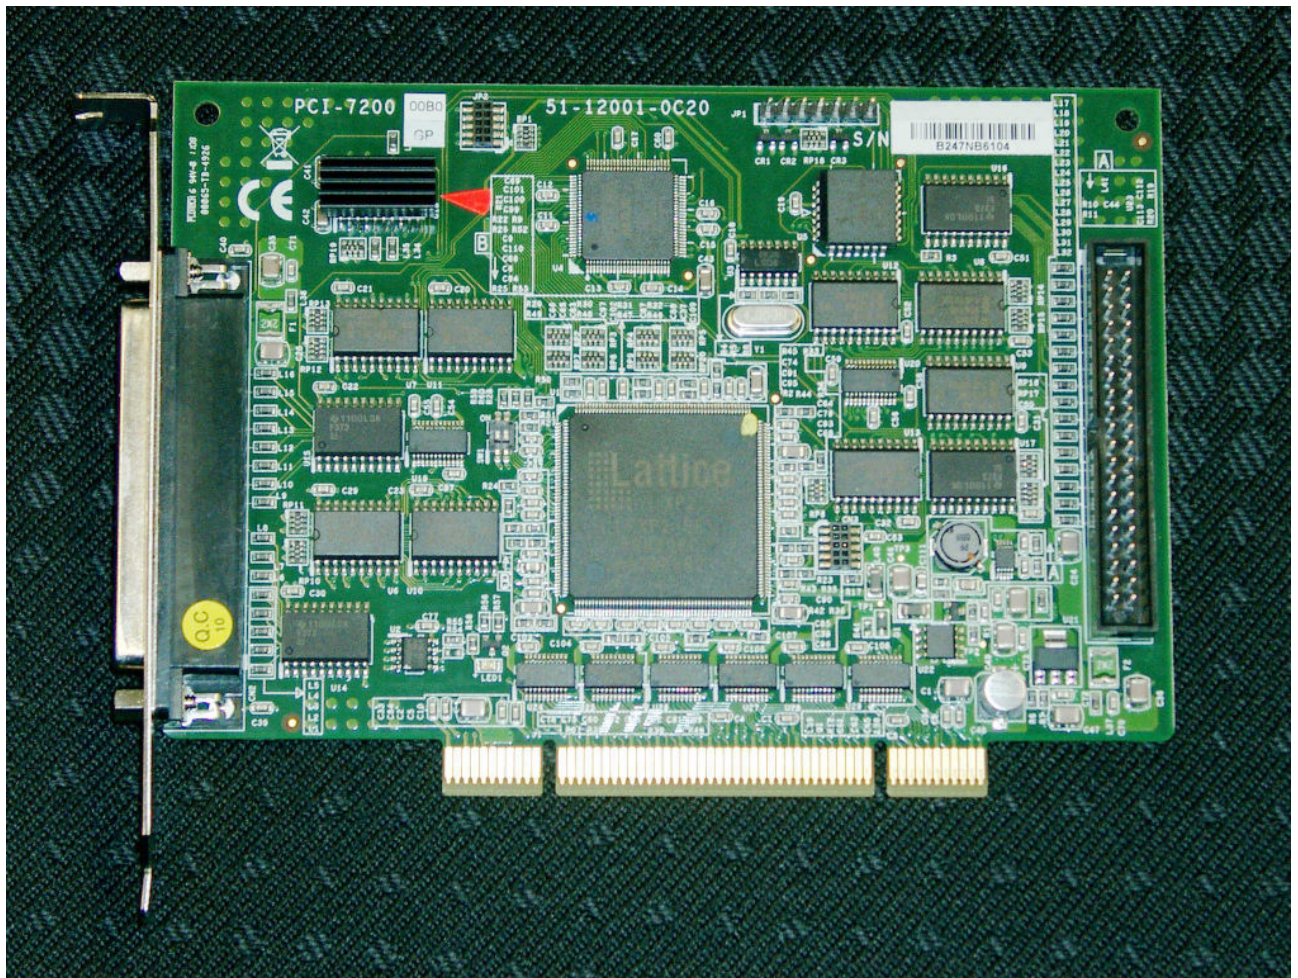
There is one driver on the PCI-7200 board controlling the write line. This driver is a 74HCT244 type. For reasons still not fully understood, this driver is burnt sometimes. This can be easily seen on the chips top, there is a bit of brown smear on the print.

As a work-around, the driver is replaced by a standard 74LS244 device. In addition a heat-sink is glued to the top. Make sure that there is a proper airflow along this board. Look after flat cables blocking the area.

The boards suffering from this problem have been repaired this way. They have been working for a prolonged period of time now without any incident.
